Golder Associates Ltd.

**LABORATORY TESTING OF
NEW AND IMPROVED BONDING COMPOUND (UTILIBOND™) AND
INVESTIGATION OF PREVIOUSLY REPAIRED PAVEMENT
KEYHOLE RESTORATION TECHNIQUES
TORONTO, ONTARIO**

April 21, 2003

021-8487

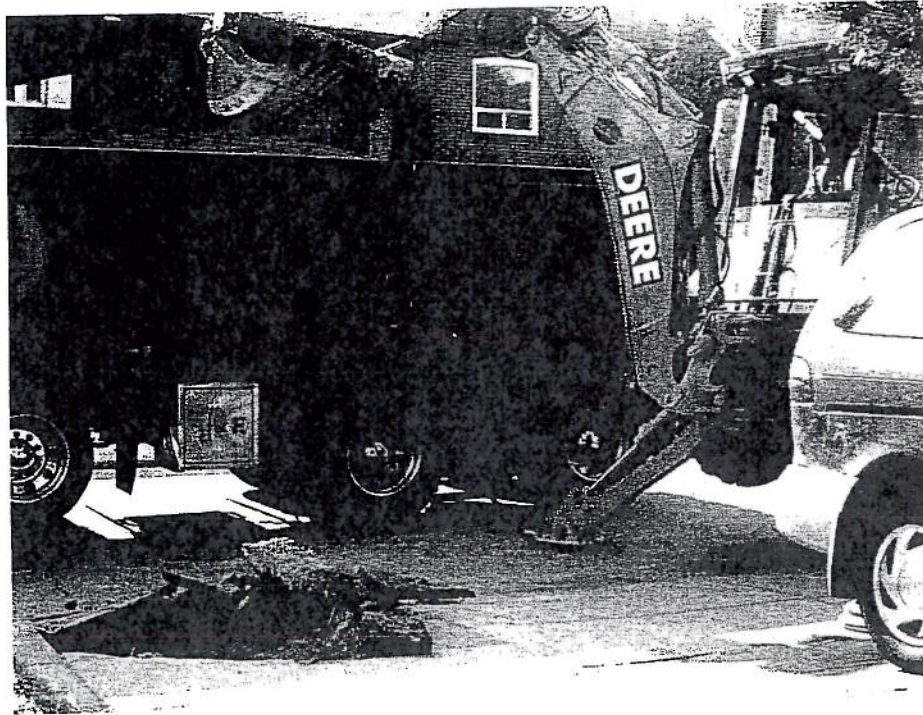
Photo 1 – Traditional utility service cut.

The technique of keyhole repair technology cost-effectively revolutionizes the manner in which utility corporations service and maintain their plant. In the past, a utility with in-ground services would be required to first carry out a pavement cut and then excavate to expose their pipes or underground plant. Traditionally, these operations required the breaking out of pavement with jackhammers, followed by backhoe excavation or manual digging until plant, pipes or fittings are exposed. The excavation would need to be large enough (i.e. one to two metres square) to allow workers to access the plant from within the excavation resulting in the generation of a large quantity of materials to be removed. In some instances, the disposal of these materials or spoil was complicated by contamination of the material that was removed. Following the repair to the service, it was necessary to backfill the hole and reinstate the pavement.

In addition to the materials generated, the procedure was a lengthy one. Given that in most municipalities, road access at peak traffic times (morning and afternoon rush hours) is restricted, the procedure would frequently require two to three days. This would result in the need to temporarily backfill the hole or otherwise protect the excavation with steel plates to allow traffic to be restored. In addition to the time requirements, there was also the requirement that many different crews and equipment types would be required to access and complete the repair of the buried plant over the several day period.

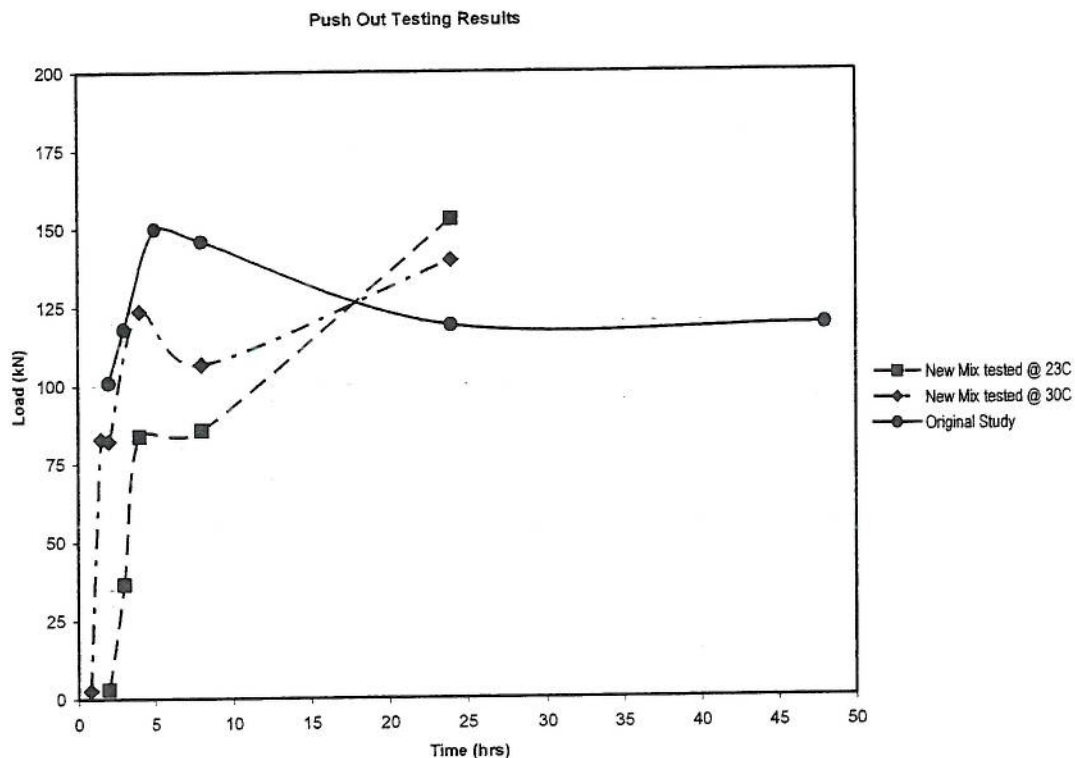
Figure 3 – Results of the Pushout Testing

The loads recorded for the Utilibond™ are presented in Figure 3. The results for products recommended after previous phases are also presented for comparison.

The graphs show that the Utilibond™ reached the necessary load capacity (4.5 kN) to support traffic within one to two hours depending on temperature. It is interesting to note that the load decreases in the short term after achieving a high strength. This effect is attributed to the initial high heat of hydration which puts the Utilibond™ annulus in compression resulting in higher initial loads. In the original testing, which was carried out over a longer time interval, this effect was seen to dissipate and normal strength gain continued. It should also be noted that in some cases, when the load exceeded 100 kN, the substrate slab broke before the bond sheared and thus the results represent a minimum strength, not that actual strength.

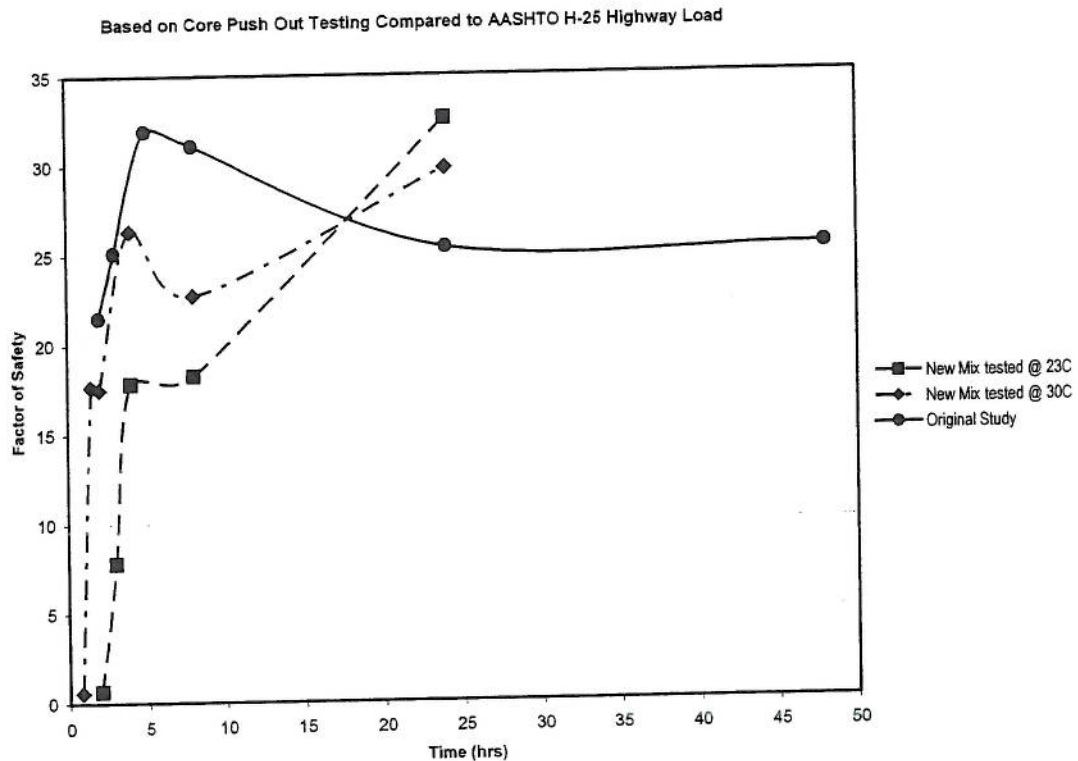
Figure 4 – Factor of Safety vs. AASHTO H-25 Loading

For the purposes of comparison, the loads have been normalized by dividing them by the calculated critical load to determine the factor of safety. As shown on the following chart,

The Utilibond™ achieves a factor of safety of five for the load within 2.5 hours at 23°C. The Utilibond™ reinstated pavement has a factor of safety in excess of 15 within 5 hours.

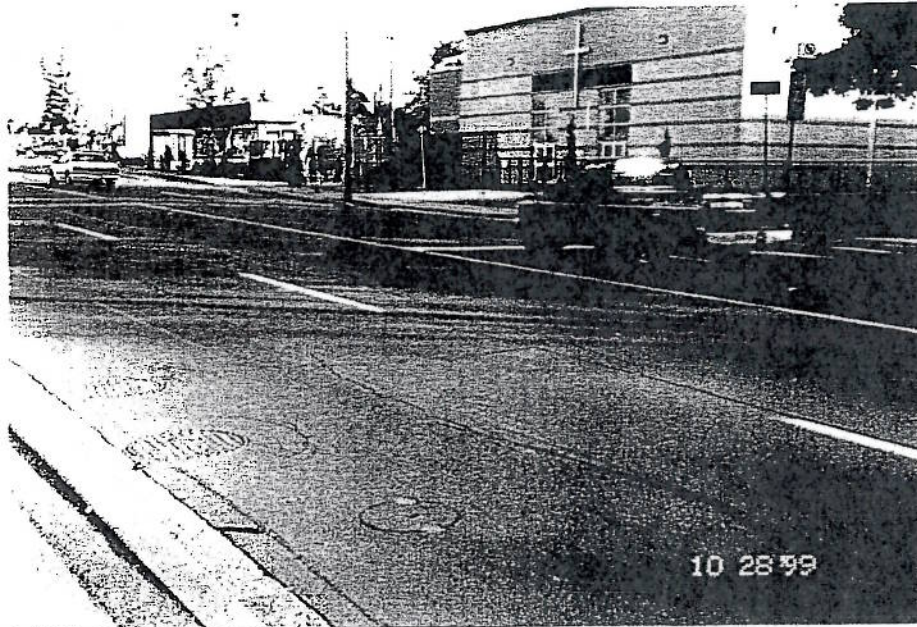
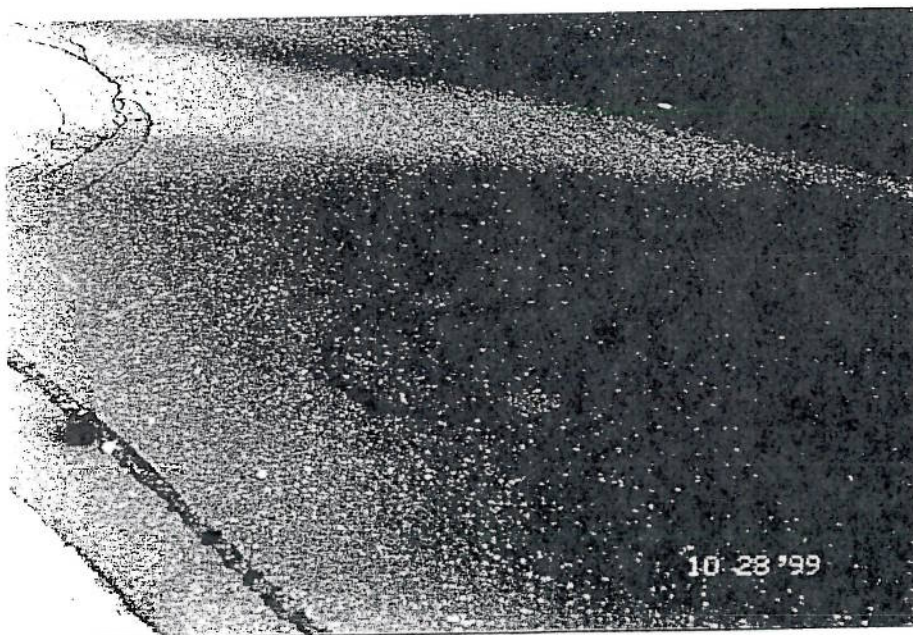
Four years later, on October 28, 1999, Photos 6 and 7 were taken by Enbridge Consumers Gas and confirm no displacement of the main core or the two satellite test cores or visible degradation of the road surface.

Photo 6 – Kennedy Road reinstatement in October 1999.

Photo 7 – Kennedy Road reinstatement in October 1999.
